# YOUR Inspection Report

64 Mordecai Lincoln Road - The Residency and Mill  
Scituate, MA 02066

RE: Report No. 2044  
64 Mordecai Lincoln Road - The Residency and Mill  
Scituate, MA  
02066

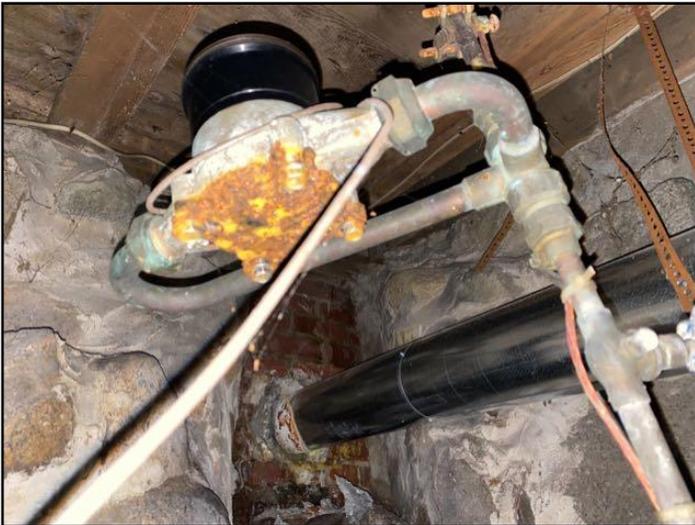
Many water line features in the basement of the residence structure have been negatively impacted the the chronic presence of moisture. Most specifically, numerous shut off valves and the underside of the water meter, where the main water line enters the basement on the left foundation wall. These valves and meter should be properly evaluated by a licensed plumber. Valve replacements should strongly be considered.

*Rusting on meter*

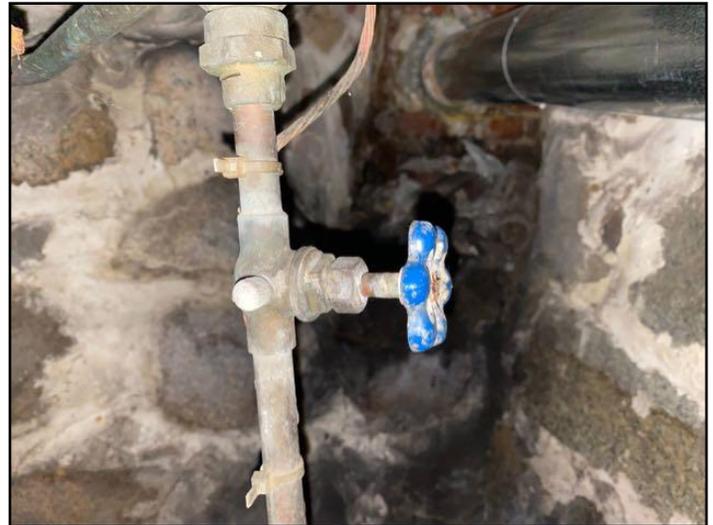
*Valves rusted on water lines*

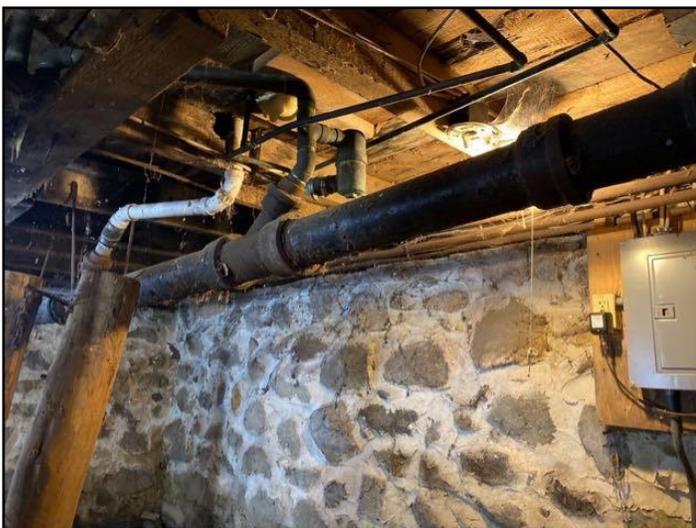
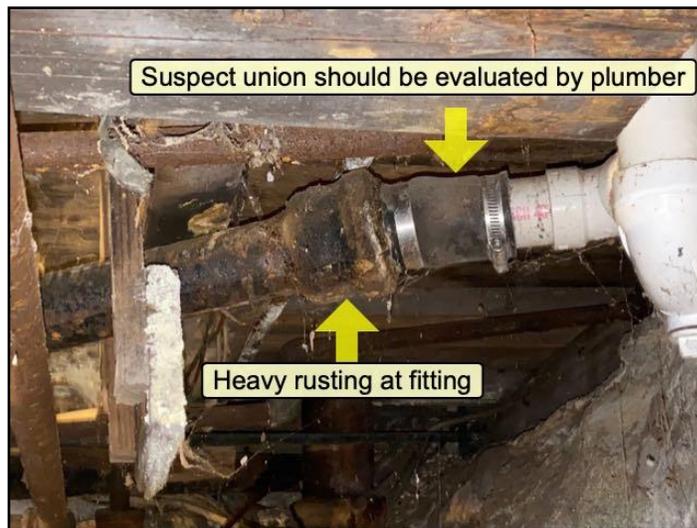
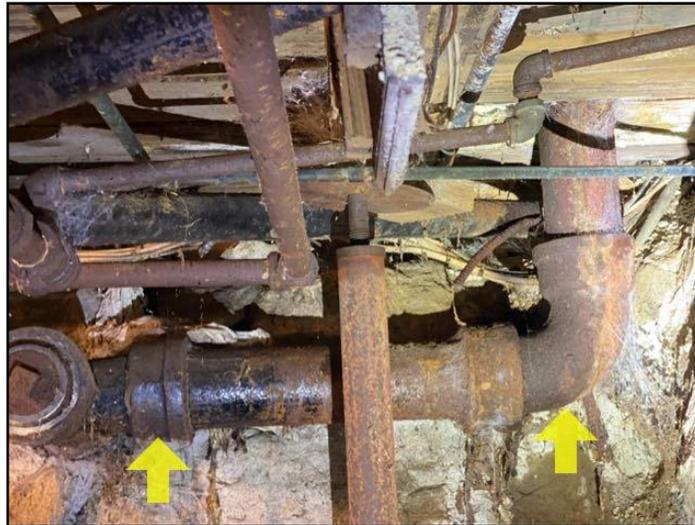
Aged and rusting cast iron drain lines

*Aged and rusting cast iron drain lines*

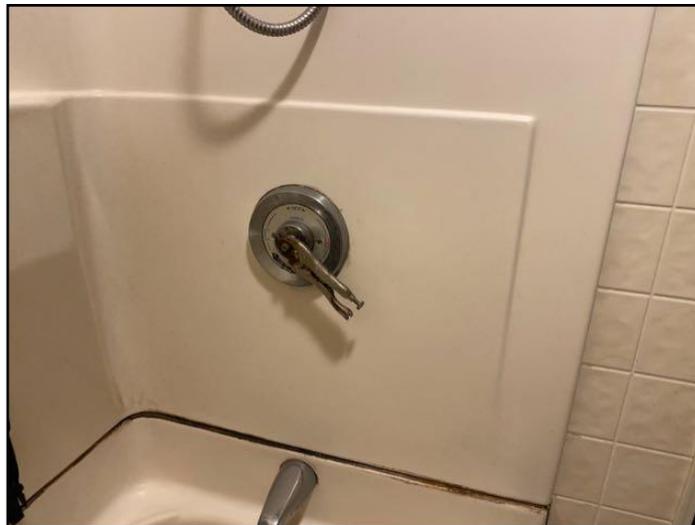
**29. Condition:** • The faucet handle for the tub/shower is in disrepair. As with the kitchen, much of the infrastructure of the bathroom is nearing exhaustion. While still usable, it is highly likely that comprehensive repairs and replacements will be needed to bring the bathroom facilities into the 21st century. Discuss with a qualified plumber and consider costs of improvement and repair.

*Failed faucet hardware*

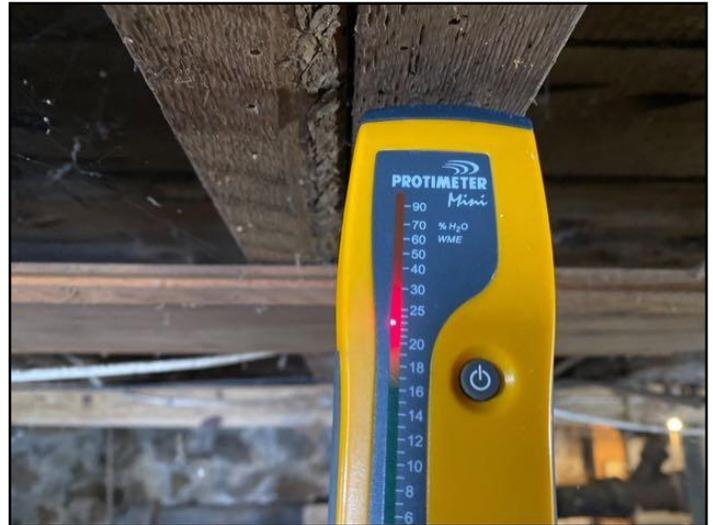
*High moisture readings throughout framing*

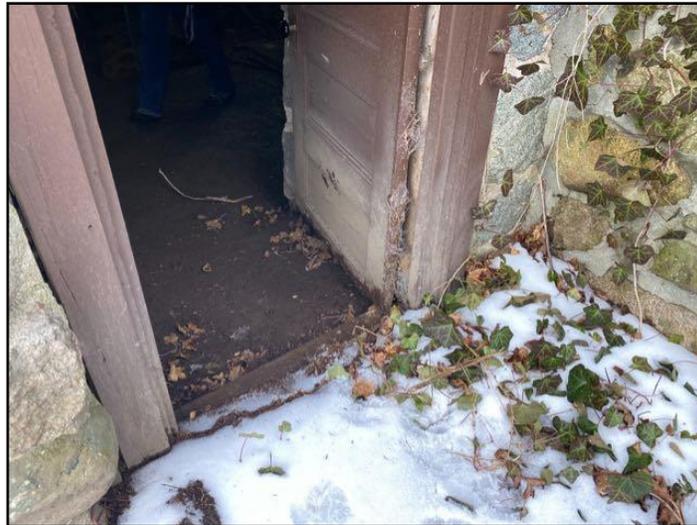
*Another water entry point*
